IS YOUR HOUSE SAFE IN A CYCLONE?

Inspection Guide for Buildings in Cyclonic Regions of the NT

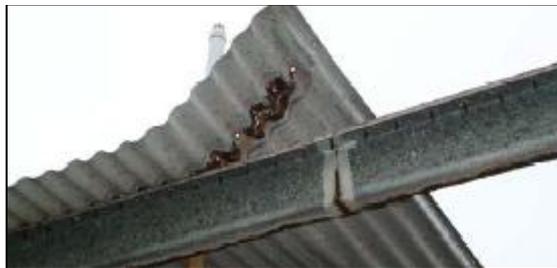
Corroded screws and cladding

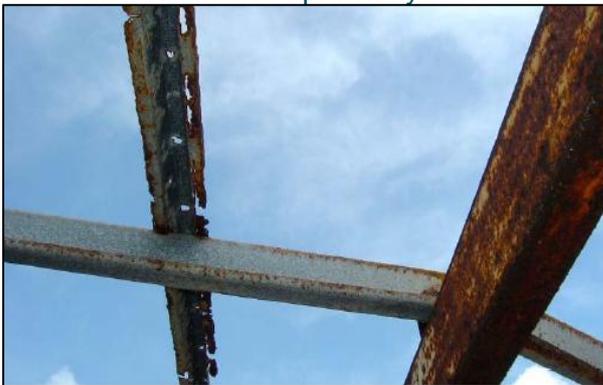
Corrosion of top hat batten

Corrosive environments can affect steel structures, reinforcing steel in concrete structures, metal cladding, metal battens, bolts, fixing plates and fixings such as cyclone assemblies (screws) and metal batten straps. This is particularly relevant to areas that are in close proximity to the coast.

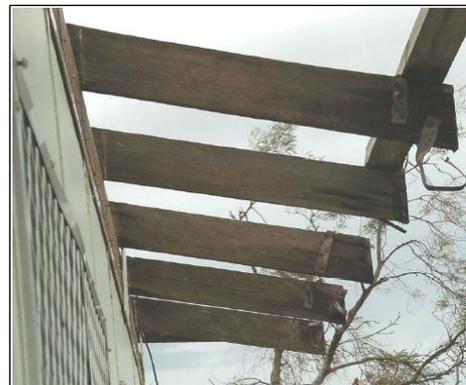
Corroded batten straps

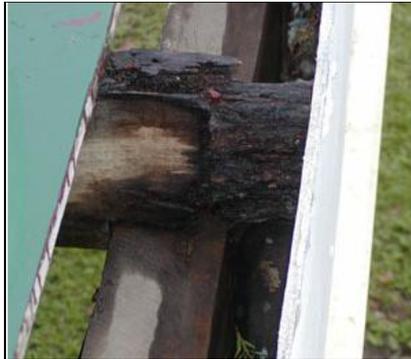
Deteriorated timber
(Floor joist at external wall connection)

Timber is affected by moist damp conditions. Wet rot is basically timber decaying naturally in the presence of high levels of moisture. This can affect structural components such as bearers, joists, flooring, timber external cladding and timber framing- particularly in exposed locations or where water leaks are present.
